## Assessment of Roof Covering Materials in an Aggressive Environment: Niger Delta Region of Nigeria

<sup>1\*</sup>, Ega, I.J., <sup>2</sup>Anowai, I.S., and <sup>3</sup>Job, O.F.

*Roof coverings in the Niger Delta region are observed to deteriorate more rapidly than in other parts of Nigeria. This study assessed the impact of an aggressive environment on roof coverings in the Niger Delta region. The study adopted a survey research design; field and data surveys to ascertain the region, the impact of weather and patterns of roof deterioration. A total of 72 samples of metallic roof covering were collected for analysis, and non-invasive techniques were used to assess the extent of deterioration on site; descriptive statistics were used for the analysis. The results show the Niger Delta region to be corrosive due to oil exploration activities with variable weather; average temperature (24.40 - 34.2)<sup>0</sup>C; however, it could be up to 40<sup>0</sup>C near flaring sites; pH is as low as 4.0 in certain locations. Among the materials studied in the region, asbestos, which is currently not in use, is the most resistant to acid rain and therefore the most durable material. The dete

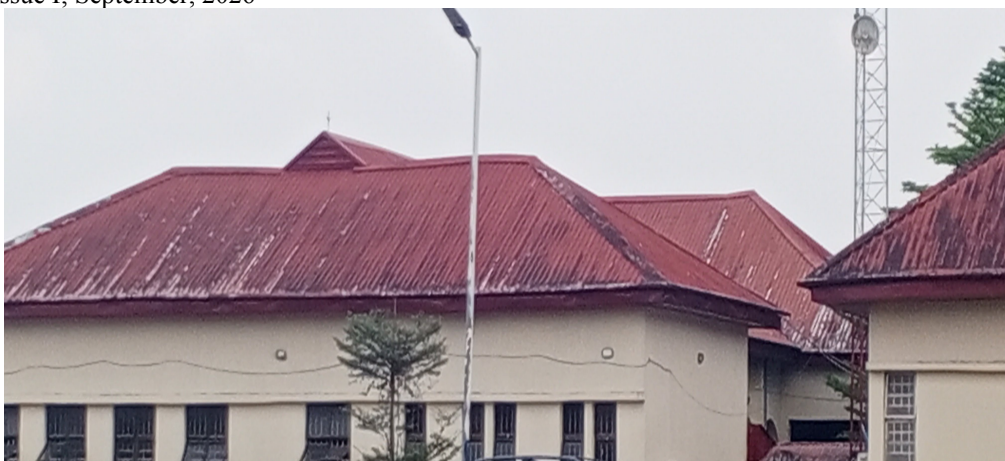
The impact of the aggressive environment on roof covering materials in the Niger Delta is shown in Figure 1. Aluminium, zinc, concrete, stone-coated steel, plastic and asbestos roof coverings were all observed to be affected. The analysis is summarised in Table 3. Zinc was the most affected among metallic materials. The implication is that zinc may need replacement more frequently than other materials. Asbestos roof coverings show some resistance to corrosive elements. However, the colour turns pale over time, and the material becomes more brittle to the touch, depending on the exposure period.

**Figure 1:** Severe corrosion and erosion along the runoff of aluminium roof covering at the sides against the wind direction in the Niger Delta.

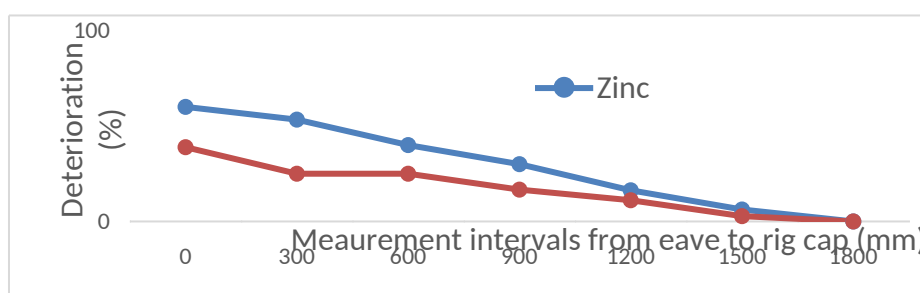
The deterioration pattern is shown in Figure 3; the deterioration, measured as a loss in thickness of both zinc and aluminium, increases towards the eave. At the eave end, the loss in thickness of zinc and aluminium is 60% and 40% respectively, while at about 1800mm from the eave end, no significant loss in thickness was recorded.

**Figure 2:** Corrosion Patterns of Metallic Roof Materials in the Aggressive Environment
