## Assessment of Roof Covering Materials in an Aggressive Environment: Niger Delta Region of Nigeria

<sup>1\*</sup>, Ega, I.J., <sup>2</sup>Anowai, I.S., and <sup>3</sup>Job, O.F.

*Roof coverings in the Niger Delta region are observed to deteriorate more rapidly than in other parts of Nigeria. This study assessed the impact of an aggressive environment on roof coverings in the Niger Delta region. The study adopted a survey research design; field and data surveys to ascertain the region, the impact of weather and patterns of roof deterioration. A total of 72 samples of metallic roof covering were collected for analysis, and non-invasive techniques were used to assess the extent of deterioration on site; descriptive statistics were used for the analysis. The results show the Niger Delta region to be corrosive due to oil exploration activities with variable weather; average temperature (24.40 - 34.2)<sup>0</sup>C; however, it could be up to 40<sup>0</sup>C near flaring sites; pH is as low as 4.0 in certain locations. Among the materials studied in the region, asbestos, which is currently not in use, is the most resistant to acid rain and therefore the most durable material. The dete

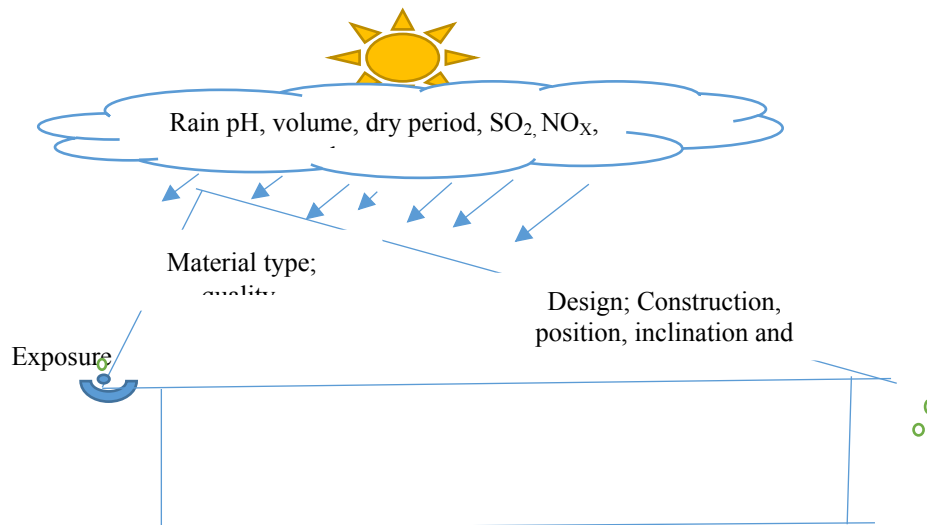
**Figure 3:** Design-Related Vulnerability Model for Roof Covering in an Aggressive Environment

The deterioration pattern is shown in Figure 3; the deterioration, measured as a loss in thickness of both zinc and aluminium, increases towards the eave. At the eave end, the loss in thickness of zinc and aluminium is 60% and 40% respectively, while at about 1800mm from the eave end, no significant loss in thickness was recorded.

Figure 3, developed from the survey, shows a model illustrating how vulnerable a roof covering can be in an aggressive environment due to design and construction. It was observed that a low roof design exacerbates or determines the rate of its deterioration in an aggressive environment. Using the model to assess a roof covering of the same material (Aluminium) shows that corrosion (deterioration) tends to increase as:

The pH value decreases; the deterioration of the roof covering increases when compared with the same roof covering materials at different locations.

The exposure period increases when compared with the same type of roof material constructed at different times in the same location. The pitch decreases- low pitches show greater corrosion than higher ones due to longer retention of corrosive elements, and this was observed when comparing similar roof materials with different pitches in the same location. One moves downward on the same pitch roof - the corrosion increases from the ridge cap in the direction of the runoff to the eave gutter, corresponding to the exposure period at which corrosive elements remain on the material surface. The heat intensity increases - the roof covering materials facing the sun's rays show an increase in deterioration compared to the other sides. Side against the wind direction - corrosion increases as the driving rain strikes the material, increasing the wear and runoff on the surface of the roof. This is evident in the level of corrosion on the material face against the wind direction compared to the non-wind direction.

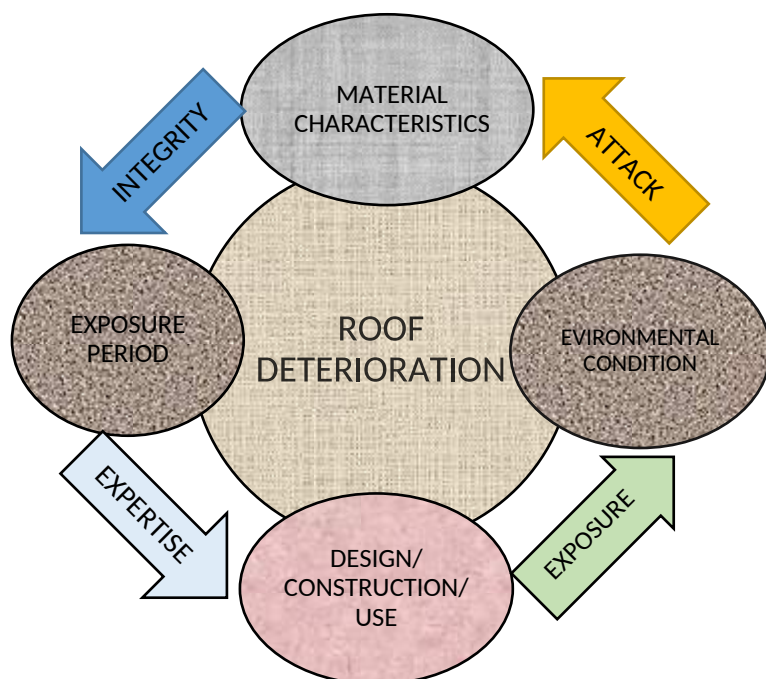
**Figure 4:** Model of Roof Deterioration Dynamics

Deterioration of roof covering materials is related to environmental conditions, material quality, design/construction and the exposure period. These deterioration dynamics and their relationships are demonstrated in Figure 4. The interactions of these dynamics are cyclic, with roof deterioration at the centre, surrounded by the four factors and four relationships. These factors are paired: the vertical pair (material characteristics and design/construction/use) and the horizontal pair (exposure period and environmental conditions). However, there is little anyone can do to alter the exposure period or environmental conditions. It is therefore important to focus on developing roof covering materials with weather-resilient characteristics and embrace designs/constructions of roofs that are weather-friendly.

Further, the deterioration dynamics are in a chain; while the aggressive elements (environmental conditions) attack the material, the rate of deterioration depends on the material characteristics. The number of years the material can serve in an aggressive environment determines its integrity or durability. However, between the exposure period and design/ construction, expertise comes into play; if the environmental knowledge is considered in the roof design and choice of materials, the rate of deterioration is likely to be reduced. On the other hand, if the roof is designed or constructed without adequate environmental consideration, the material becomes more vulnerable to deterioration. Therefore, inadequate roof design in an aggressive environment increases deterioration.
